Zbigniew RACZYŃSKI

## STUDY OF THE MECHANICAL PROPERTIES OF THE MS-40 BRIDGE SPAN

**Abstract.** The paper presents selected results of strength tests of the MS-40 bridge span. The tests included static loading of the bridge as specified by the standard for MLC 70 (T) class - tracked vehicles - and MLC 110 (W) class - wheeled vehicles. Stresses in selected points of the main and auxiliary spans of the bridge were recorded during the tests.

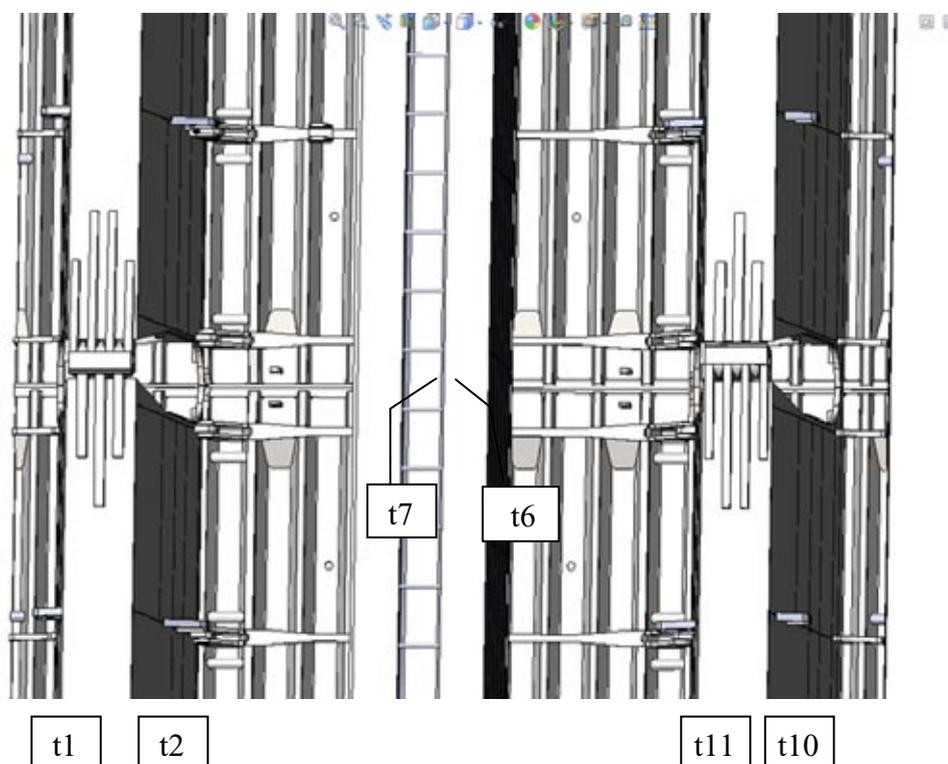
**Fig. 2. Schematic of the arrangement of strain gauges on the lower chord of the middle segment of the main span and auxiliary span**

Six strain gauges of the TFs-10 type (Fig. 2) were affixed to the lower chord of the main span in the middle of the bridge length at points indicated by OBRUM design engineers [3]. These gauges are marked as: t1 – t3 and t9 – t11. Two strain gauges were affixed halfway of the length of the auxiliary span, which forms a support when segments of the main span are arranged (steel structure of rectangular shape): t6 (top) and t7 (bottom).

The gauges were arranged so that the datum direction was parallel to the longitudinal axis of the tested span.

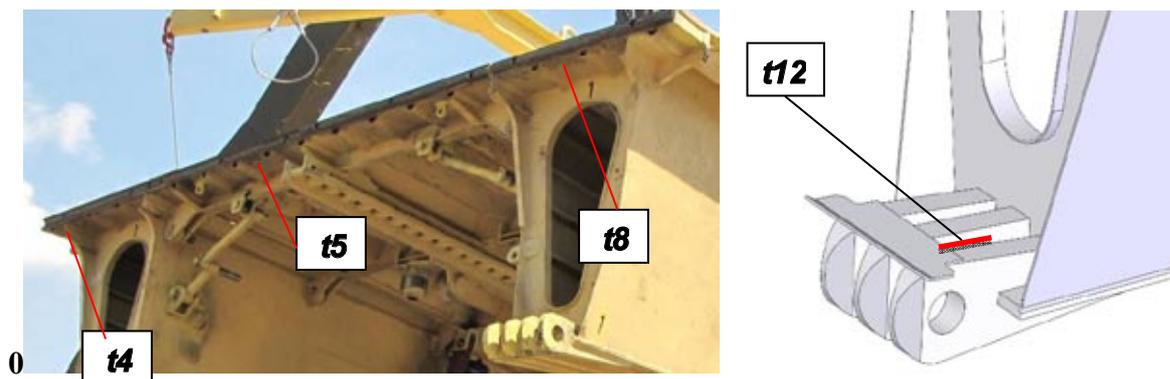
Fig. 3. Arrangement of other strain gauges on the middle segment of the main span

To be able to assess the strength of the entire span, rather than that of the lower chord only, four additional single strain gauges were affixed at selected points halfway of the length of the main span (datum direction parallel to the longitudinal axis of the span). These gauges are indicated in Fig. 3 as: t4, t5, t8 and t12.

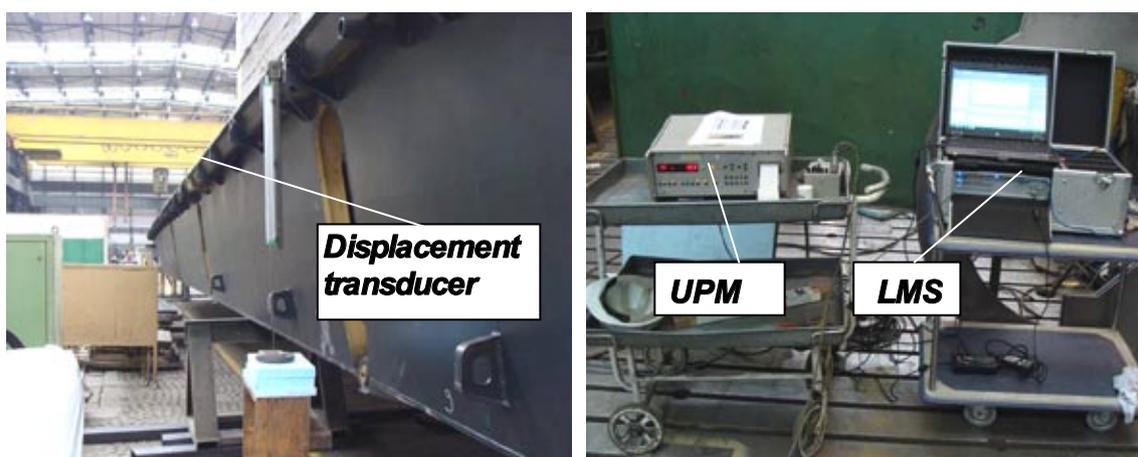
Fig. 4. Displacement transducer and measuring apparatus

All strain gauges were connected to multichannel logging device UPM60 from HBM (Fig. 4) to collect relative elongation measurement data from the strain gauges. Temperature compensation for the strain gauges is provided by the manner of connecting to UPM60 through a VT21 terminal block, with a compensating gauge of the same type connected (every strain gauge channel in a semi-bridge arrangement).

Measurement of the sag at half length of the span was done using a potentiometric displacement sensor from Buster (Fig. 4) with a measuring range of 600 mm and nonlinearity error  $\pm 0.05\%$ , connected to an LMS Scadas Mobile recorder, and Leica DISTO A5 laser distance meter.

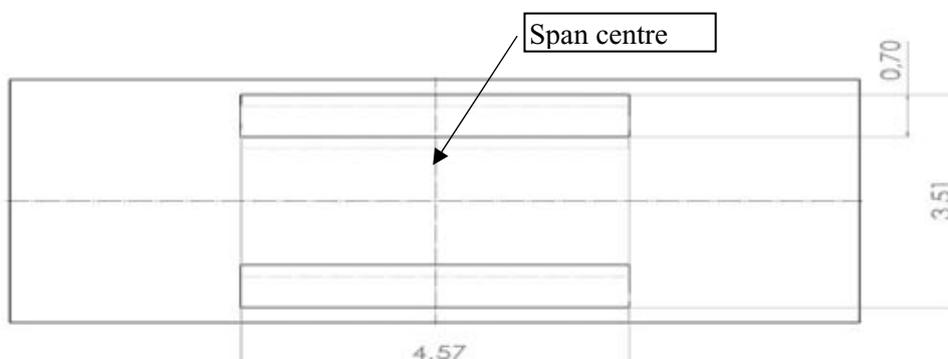
Fig. 5. Dimensions of the frame for simulating MLC 70(T) load and its position on the bridge span

To apply loads onto the bridge span according to STANAG 2021 for tracked vehicles of the MLC 70(T) class, a special frame (contact area with span ca. 4.57 m long and ca. 0.7 m wide with pads of hard rubber 45 mm thick) was prepared to imitate tank tracks. The frame was set along the axis of the bridge span as shown in Fig. 5.

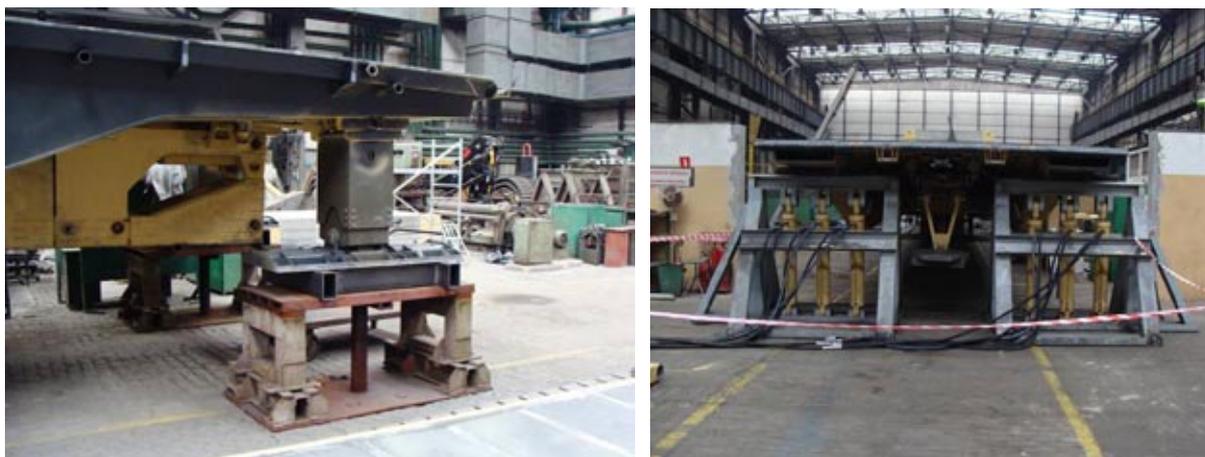
**Fig. 6. Manner of supporting ends of the main span of the bridge**

The span was supported on one side on its own supports, and on the other side on a special frame (Fig. 6) and it was levelled. The structure of the frame on the right side of the drawing (with hydraulic cylinders) enables testing the span subjected to cyclic fatigue load (not the subject of this article).

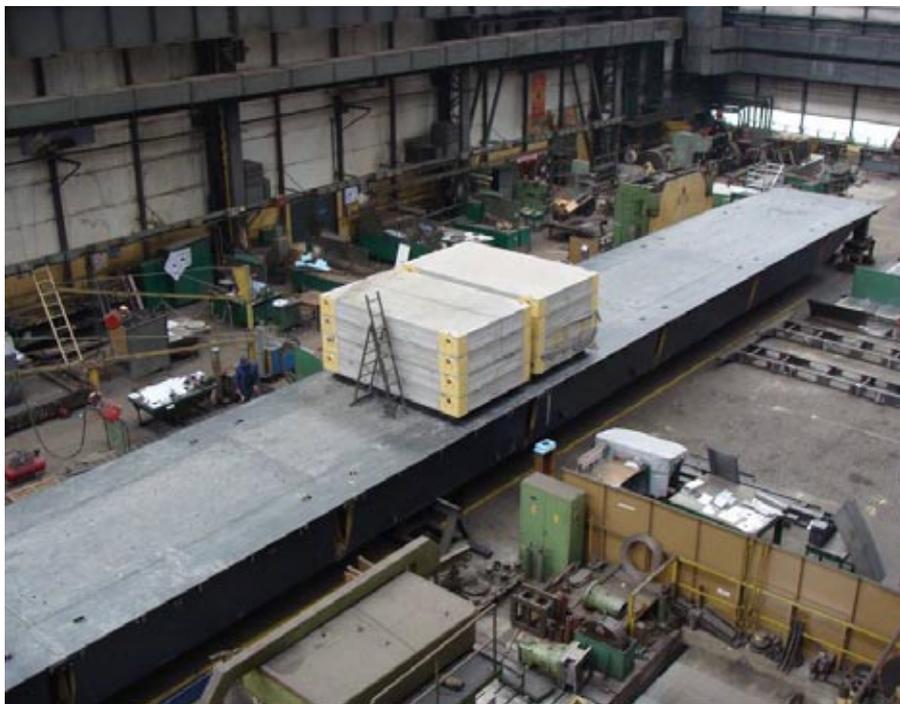
**Fig. 7. Span during the "P" test – load from vehicle tracks**

Concrete blocks, two in each layer, were set on the frame in succession. The loading step was ca. 16 t. The blocks were weighed when positioned on the span. The weight of the frame (1.64 t) was taken into account when loads were applied to the span.

The load was increased gradually (Fig. 7) and stresses and deflections on both sides of the span were recorded. Every subsequent load was maintained for 2 minutes.

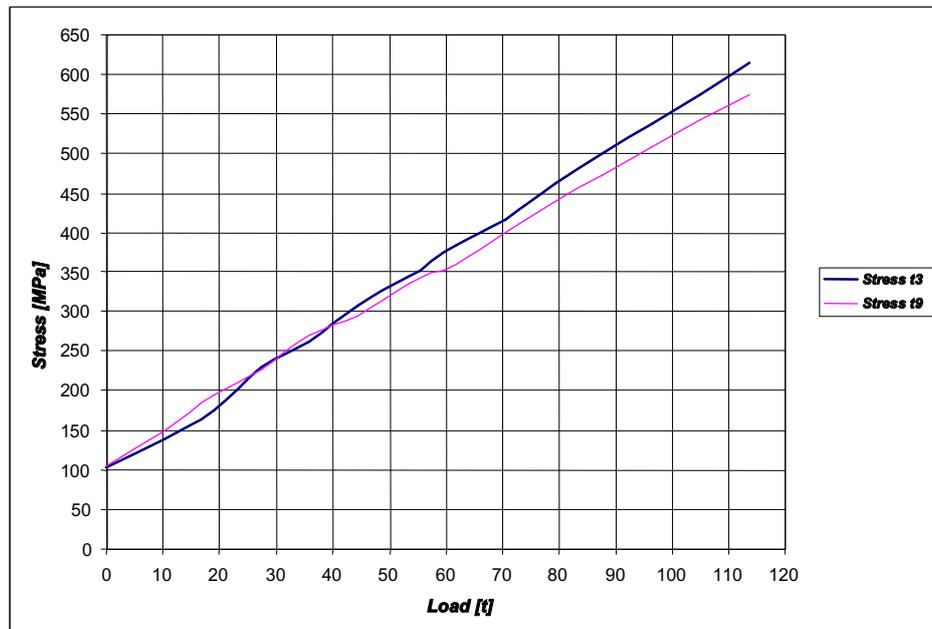
**Fig. 8. Stresses measured on gauges t3 and t9 - vehicle track load**

Figs. 8 and 9 show graphs of stresses measured on selected gauges, and Fig. 9 shows a graph of deflection of the bridge span under load.

Stresses resulting from main span dead weight for the lower chords under consideration are equal to ca. 100 MPa, therefore the graph (Fig. 8) is shifted up by this value.

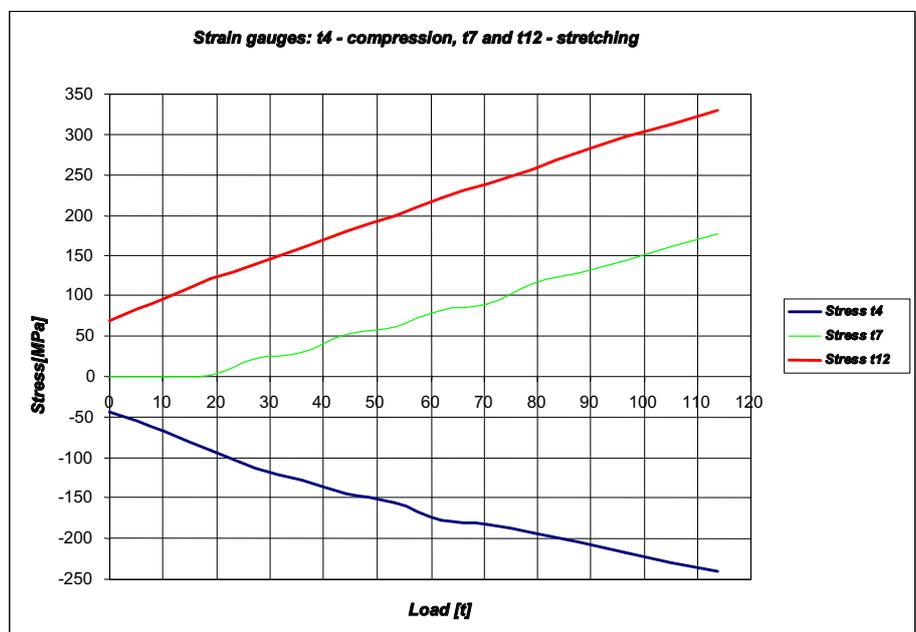
**Fig. 9. Stresses measured on gauges t4, t7 and t12 - vehicle track load**

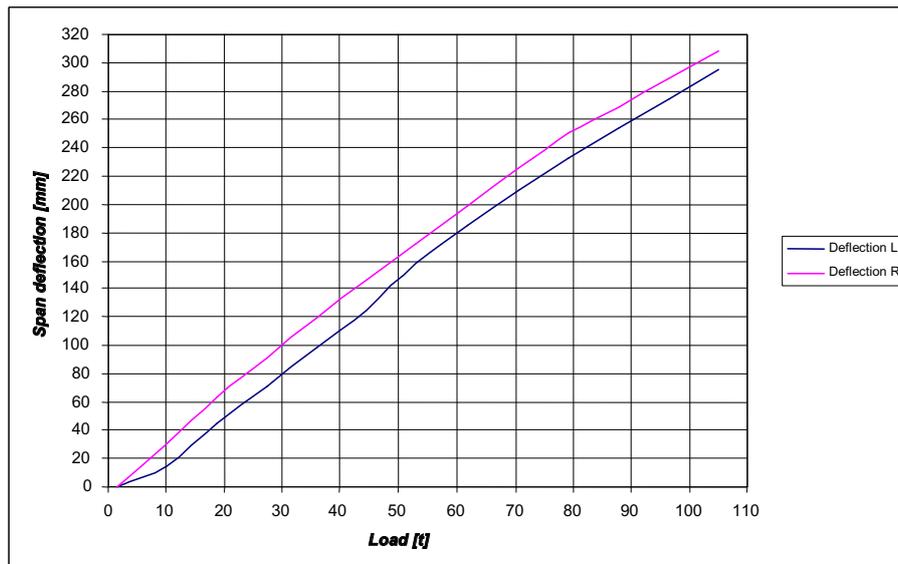
**Fig. 10. Deflection measured in the middle of the MS-40 bridge span - vehicle track load**

The characteristics of span deflection (Fig. 10) indicate that the left side of the span differs only slightly from the right side. This results from the loose support of the bridge on one side. After the play is taken in, the characteristics of deflection are identical within error limits.

The deflections indicate the increasing role of the auxiliary span in the taking over of the loads (stiffness of the span increases – lower deflection increment under load).

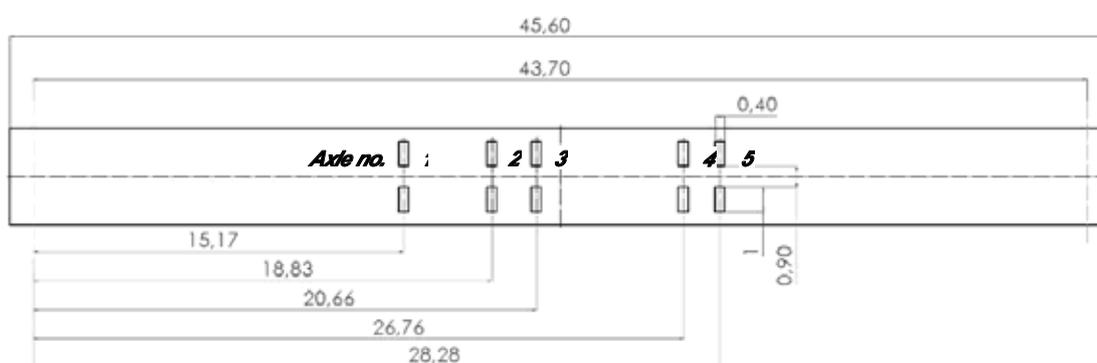
Fig. 11. Arrangement of rubber pads on the span

The pads were arranged on the span as shown in Fig. 11, so that the centre of gravity of the entire arrangement closely corresponded to the geometric centre along the longitudinal axis of the span. Distance between the pads (wheel base) is defined by the MLC 110 (W) class standard vehicle model.

Concrete blocks were set in succession on the span with the rubber pads arranged on it (Fig. 11). The load was increased gradually with an average increment of ca. 8.5 t and stresses and deflections on both sides of the span were recorded.

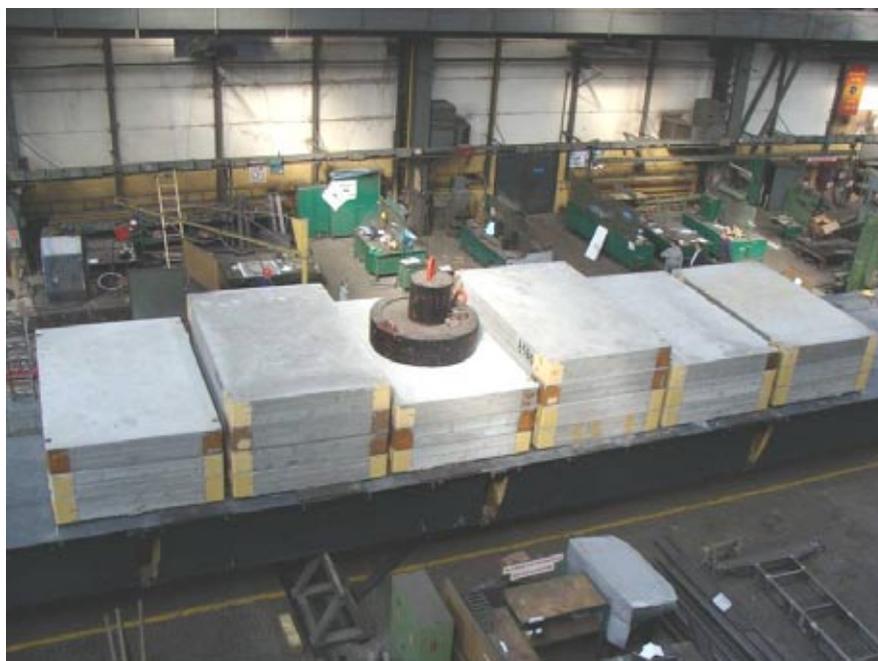
**Fig. 11. Span loaded with weights during the "U" test - wheeled vehicle load**

The ultimate load test was run only once, with the set "U<sub>r</sub>" load maintained for 30 minutes. Due to the shortage of concrete blocks, additional steel weights were used for the last applied load (Fig. 11).

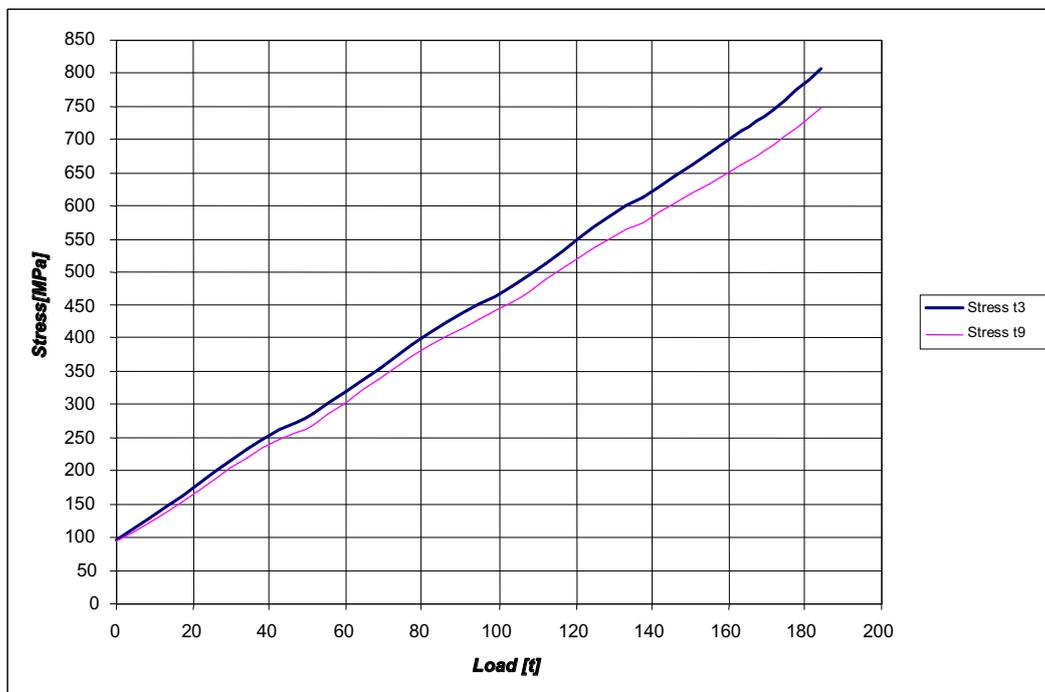
Fig. 13. Stresses measured on gauges t3 and t9 - vehicle wheels load

The strains are virtually linear in nature. It is only when the 140 t load is exceeded that slight nonlinearity occurs (faster stress increase on graph in Fig. 13).

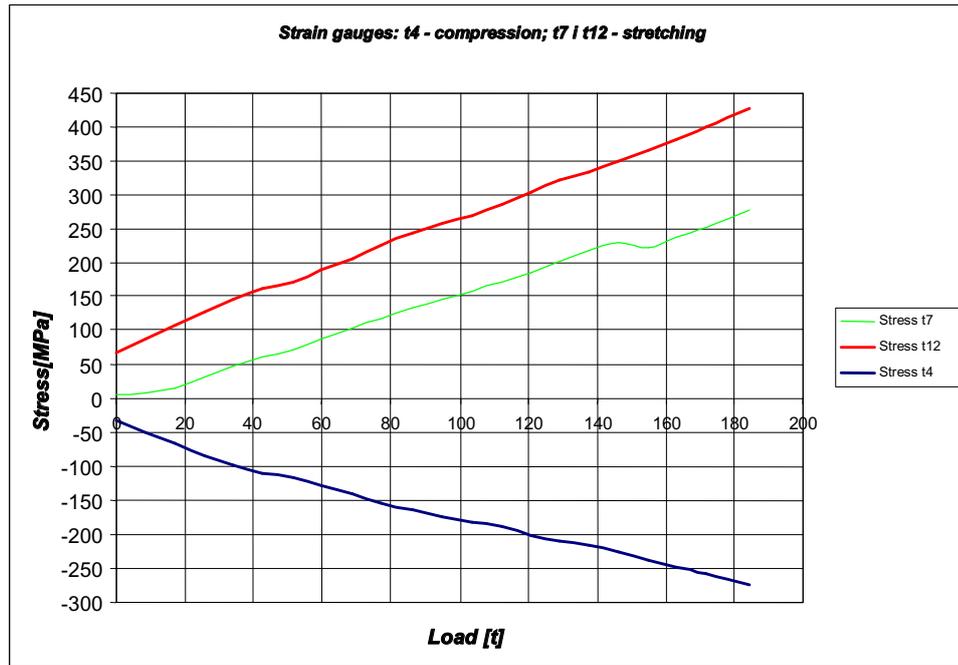
Fig. 14. Stresses measured on gauges t4, t7 and t12 - vehicle wheels load

Figs. 13 and 14 show graphs of stresses measured on selected gauges, and Fig. 15 shows a graph of deflection of the bridge span under load.

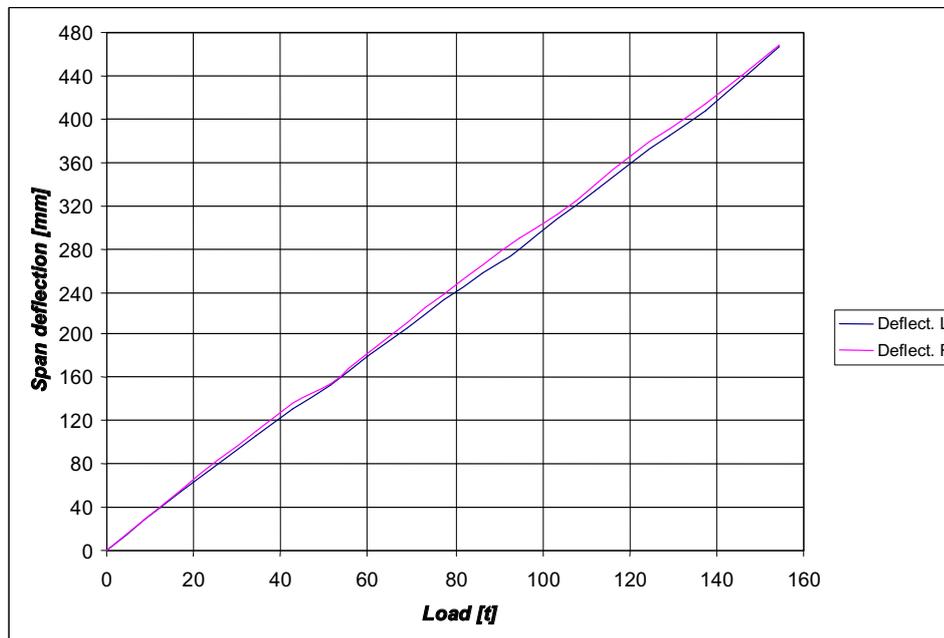
Fig. 15. Deflection measured in the middle of the MS-40 bridge span - vehicle wheels load

The characteristics of deflections (Fig. 15) indicate that the left and right sides do not differ. Any possible play remaining after previous application of loads has been eliminated.

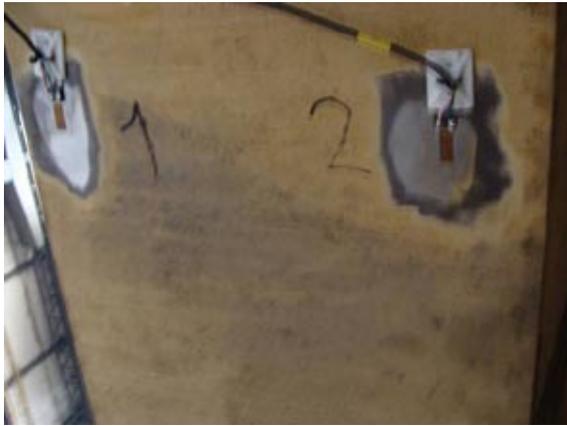
Gauges t1 and t2 – lower right chord of the middle segment of the main span

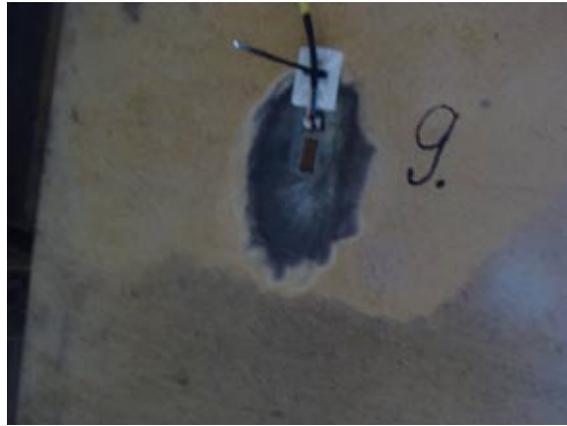
Gauge t9 – lower left chord of the middle segment of the main span

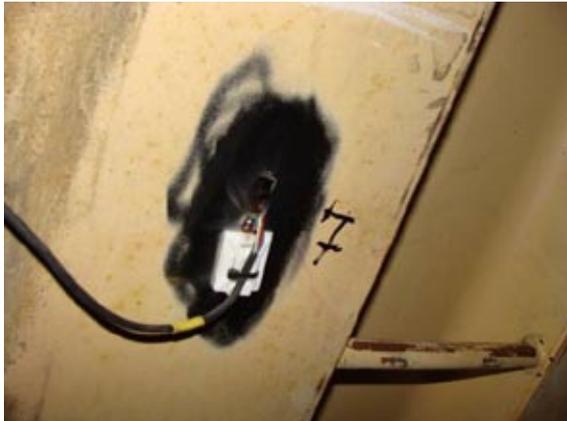
Gauge t7 – lower chord of the middle segment of the auxiliary span

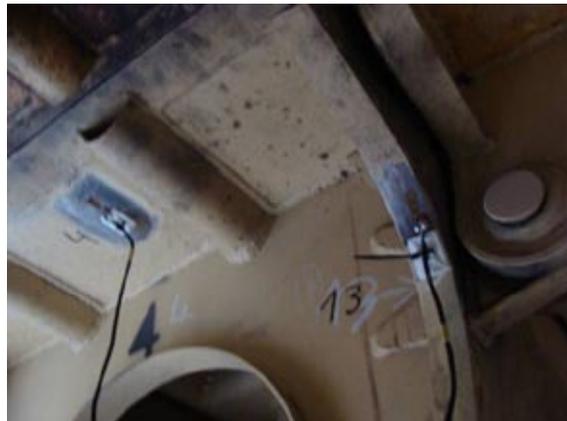
Gauges t4 and t13 – deck underside and vertical wall of the middle segment of the main span

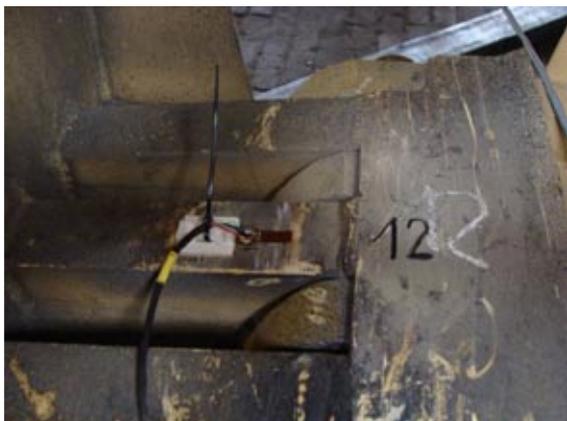
Gauge t12 – lug beside the bolt of main span

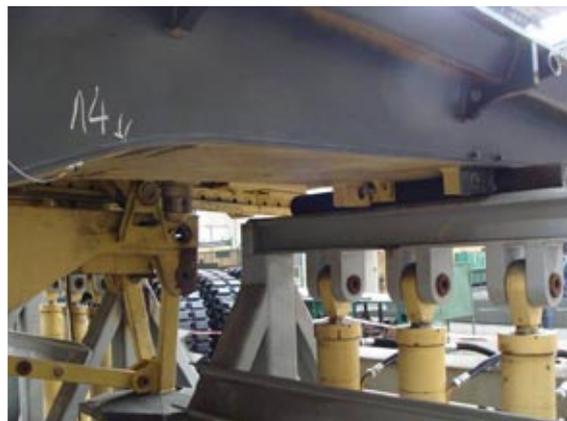
Gauge t14 – lower right chord of the approach segment of the main span
